1012: Ethernet Adapter

MOHR sells an adapter kit that can be used for testing Ethernet cables terminated with RJ-45 connectors (EIA 568B colors). This application note will demonstrate the use of the kit testing a patch cable with a defect. This note is part of a series. It is assumed that the reader has previously read or learned the topics previously discussed.

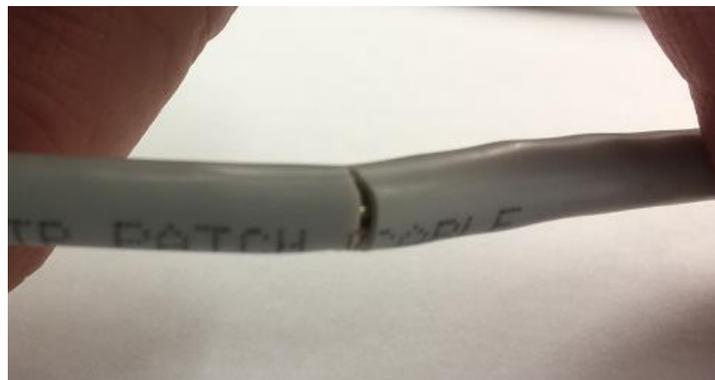
The cut in the cable sliced through two of the individual wires, affecting two of the wire pairs in the cable.

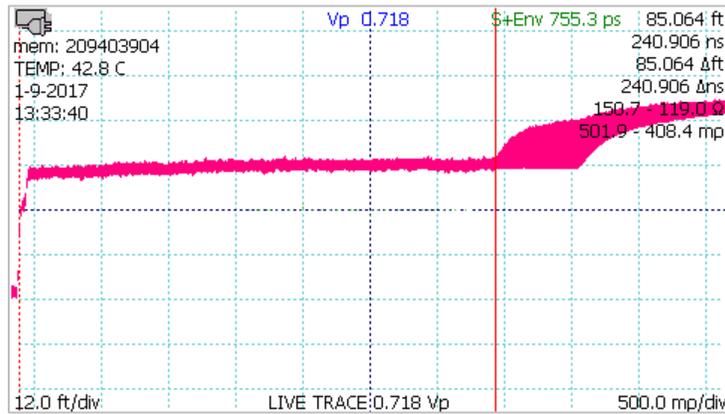
If this cable were known to have an intermittent failure, we could have used the Envelope Plot option for each pair while flexing the cable. The plot below shows the Envelope Plot for the Pin 3&6 pair.
